DipStick Blues.

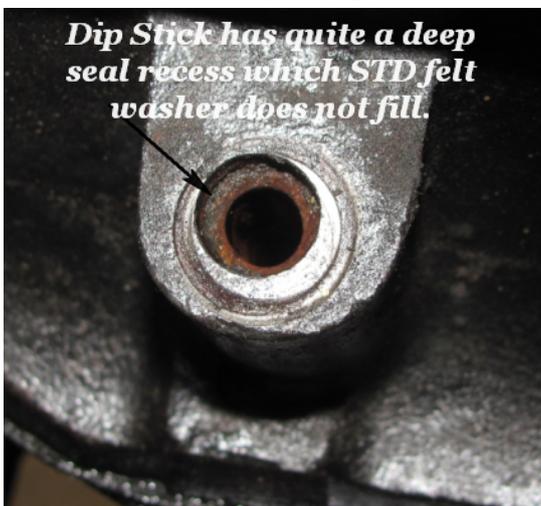
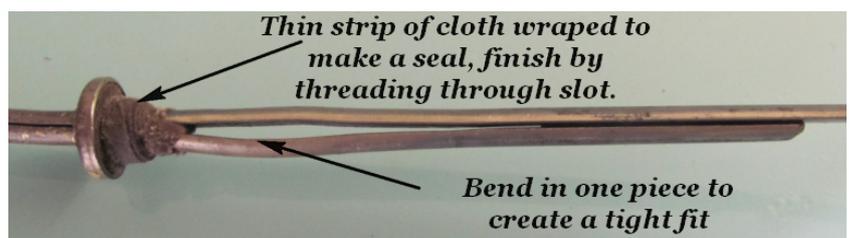
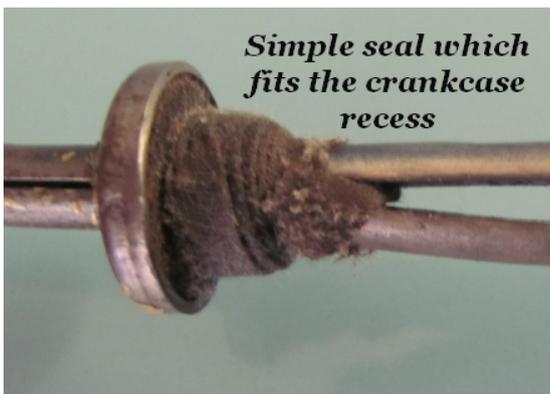
Now during my enlightenment it was also pointed out that most apparent rear oil seal leaks are actually caused by incorrectly fitting DIP Sticks. Apart from interfering with the delicate negative pressure the

oil exits from the dip stick, travels along the sump flange and then onto the ring gear shield, thus making it look like the oil came from the main seal.

Rick enlightened me as to how important it is to have the dip stick both sealed and a tight fit.

Lunch at Tathra beach café was great, the new breather fitted perfectly and was the correct TR3A one this time rather than a TR2 one I must have had originally which was the cause of the interference with filter casing. The 3A one has a cranked down pipe and the TR2 one is straight.

The massive oil leak vanished and we were now back to the normal TR oil osmosis for our journey home.
