TR REGISTER AUSTRALIA

TECHNICAL TIPS.

TECHNICAL TIPS

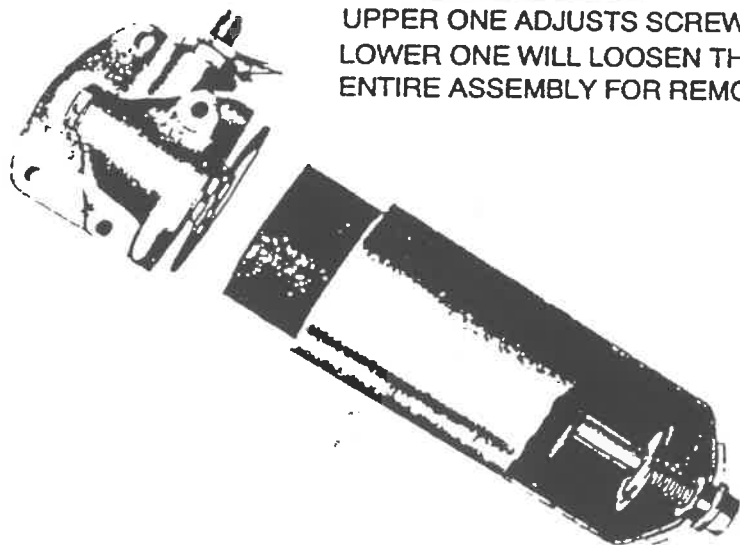
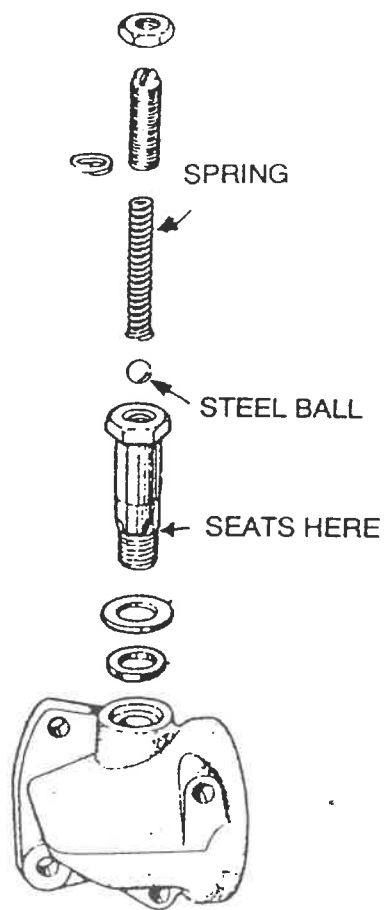
UPPER ONE ADJUSTS SCREW
LOWER ONE WILL LOOSEN THE
ENTIRE ASSEMBLY FOR REMOVAL

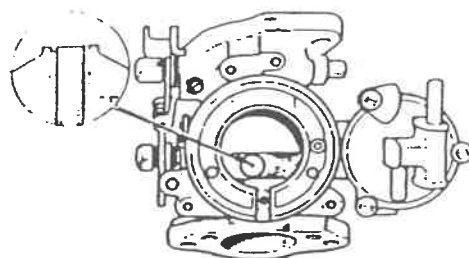
JET MUST BE CENTERED AS SHOWN IN ILLUSTRATION.

LOOSENING SCREWS (#8) AND ROTATING DASHPOT DOME SLIGHTLY MAY HELP.

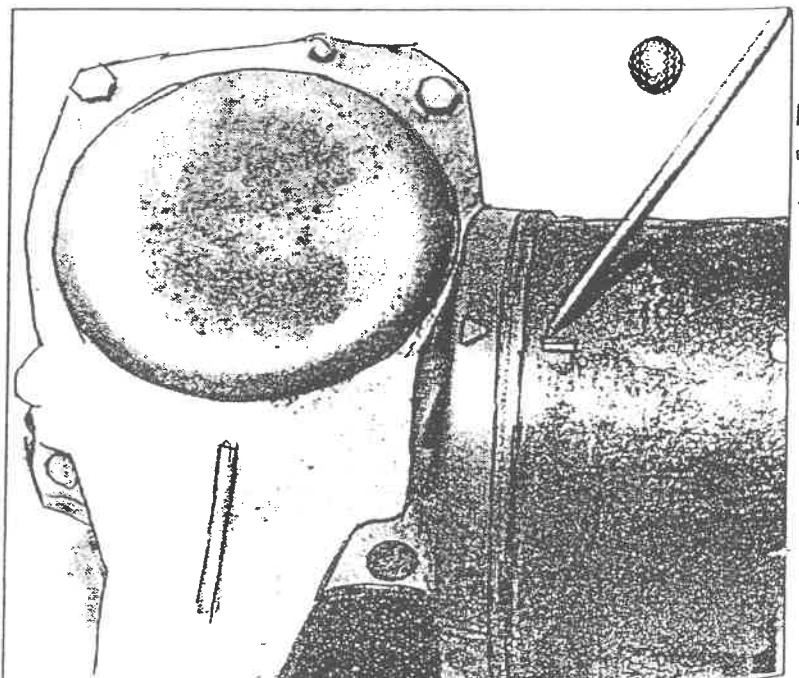
A check of the two marks in alignment will ensure the yoke is correctly fitted to the wiper gearbox.

Also, make sure you've replaced the yoke correctly to the gearbox. There are two marks - see picture, right - which should be aligned, although these can sometimes be indistinct if the casing has corroded.

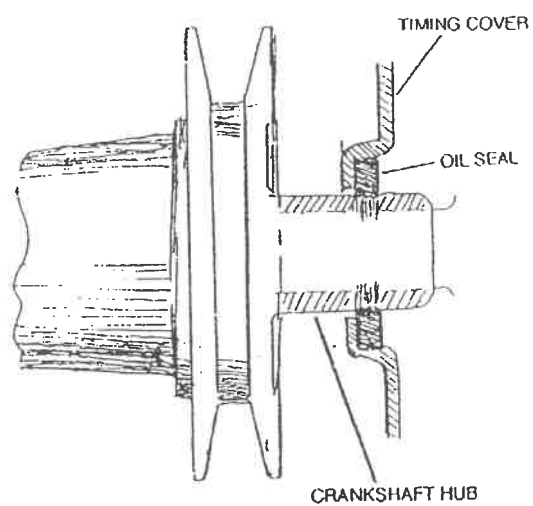
SPEEDI-SLEEVE PRESSES OVER WORN HUB TO PRESENT
A NEW SMOOTH SURFACE FOR OIL SEAL TO RIDE ON.

These repair sleeves are available from most of the major triumph parts suppliers (including BFE with a price of \$26.45) and make a very long lasting repair that will do wonders to clean up that messy leak at the front that blows oil all over everything as we drive along.

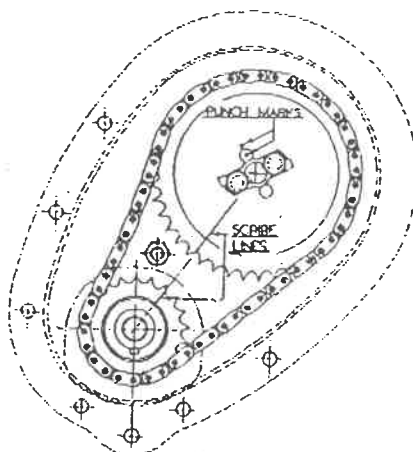
TIMING marks aligned for setting. Note that the keyway is at the bottom of crankshaft sprocket.

Remove the feeler gauge and turn the flywheel forward until the gauge can be freely inserted at the exhaust valve, then turn the flywheel to T.D.C. Turn the flywheel slowly forward, exerting a slight pull on the feeler gauge and when the feeler can be withdrawn, the exhaust valve must be closed. Now make a second mark on the flywheel and measure the distance from T.D.C. to each mark. These should be the same. Don't forget to lock the tab washers of the chainwheels if the timing is found to be O.K. The timing wheels are then marked by a scribe which should run through the centres of both wheels.

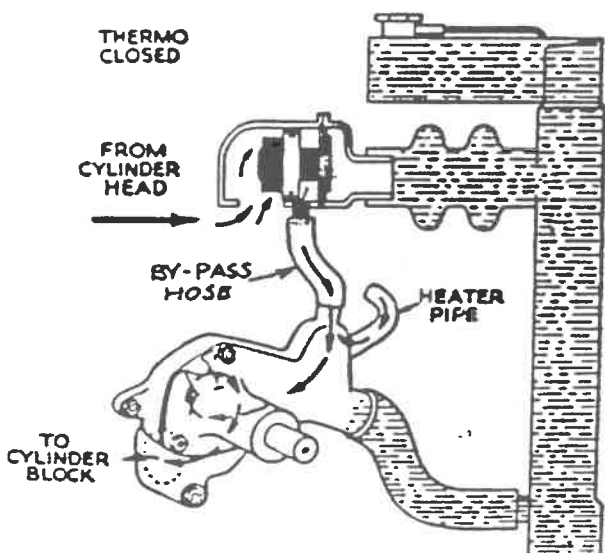
Circulation of Water before the Thermostat has opened

Circulation when the Thermostat is

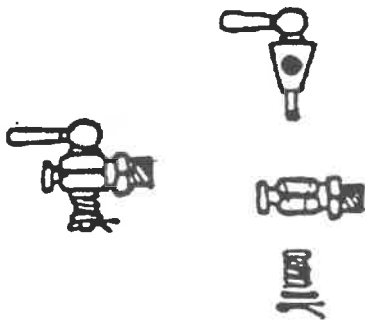
Curing leaky petcocks is no real problem. Remove the cotter pin at the bottom, remove the spring, and gently tap out the valve. Soaking the assembly in penetrating oil first usually helps.

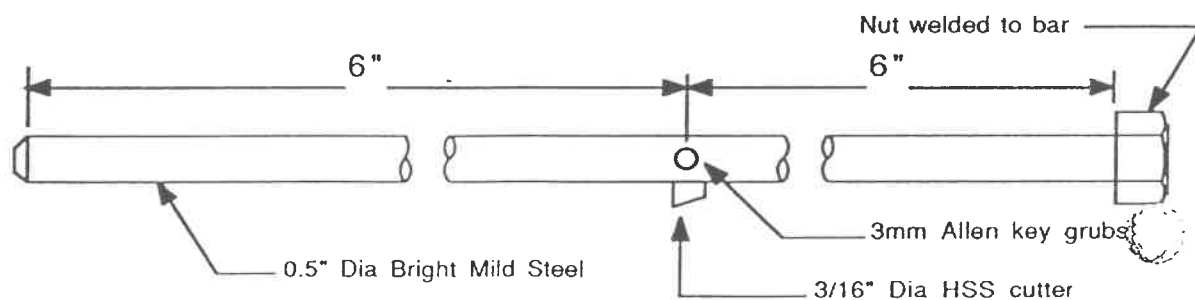
The tool can best be turned by means of an appropriate socket and brace type drive. Fine adjustments need to be made to the distance that the cutter protrudes so that the counterbore matches the OD of the seal. Trial fit the seal when the counterbore is only 1 or 2 mm deep - the counterbore needs to be 0.187" deep. Kerosene is the correct lubricant for aluminium. A tiny amount of silicone rubber around the outside of each seal will ensure a completely oil-tight selector shaft.

These ineffective "O" rings seemed to be the source of the trouble. A few measurements and enquiries revealed that a modern oil seal of the correct dimensions is available but not readily over the counter in NSW. The nearest easily obtainable seal is the type which is fitted to the Holden Trimatic gearbox selector shafts (PBR # PR6361). They are 1/2" ID but require boring out to 0.75" to accept the OD. A few more calcs. revealed that there was enough "meat" in the gearbox cover between the shafts to allow these seals to fit so I constructed a boring tool to the specs shown in the attached drawing.

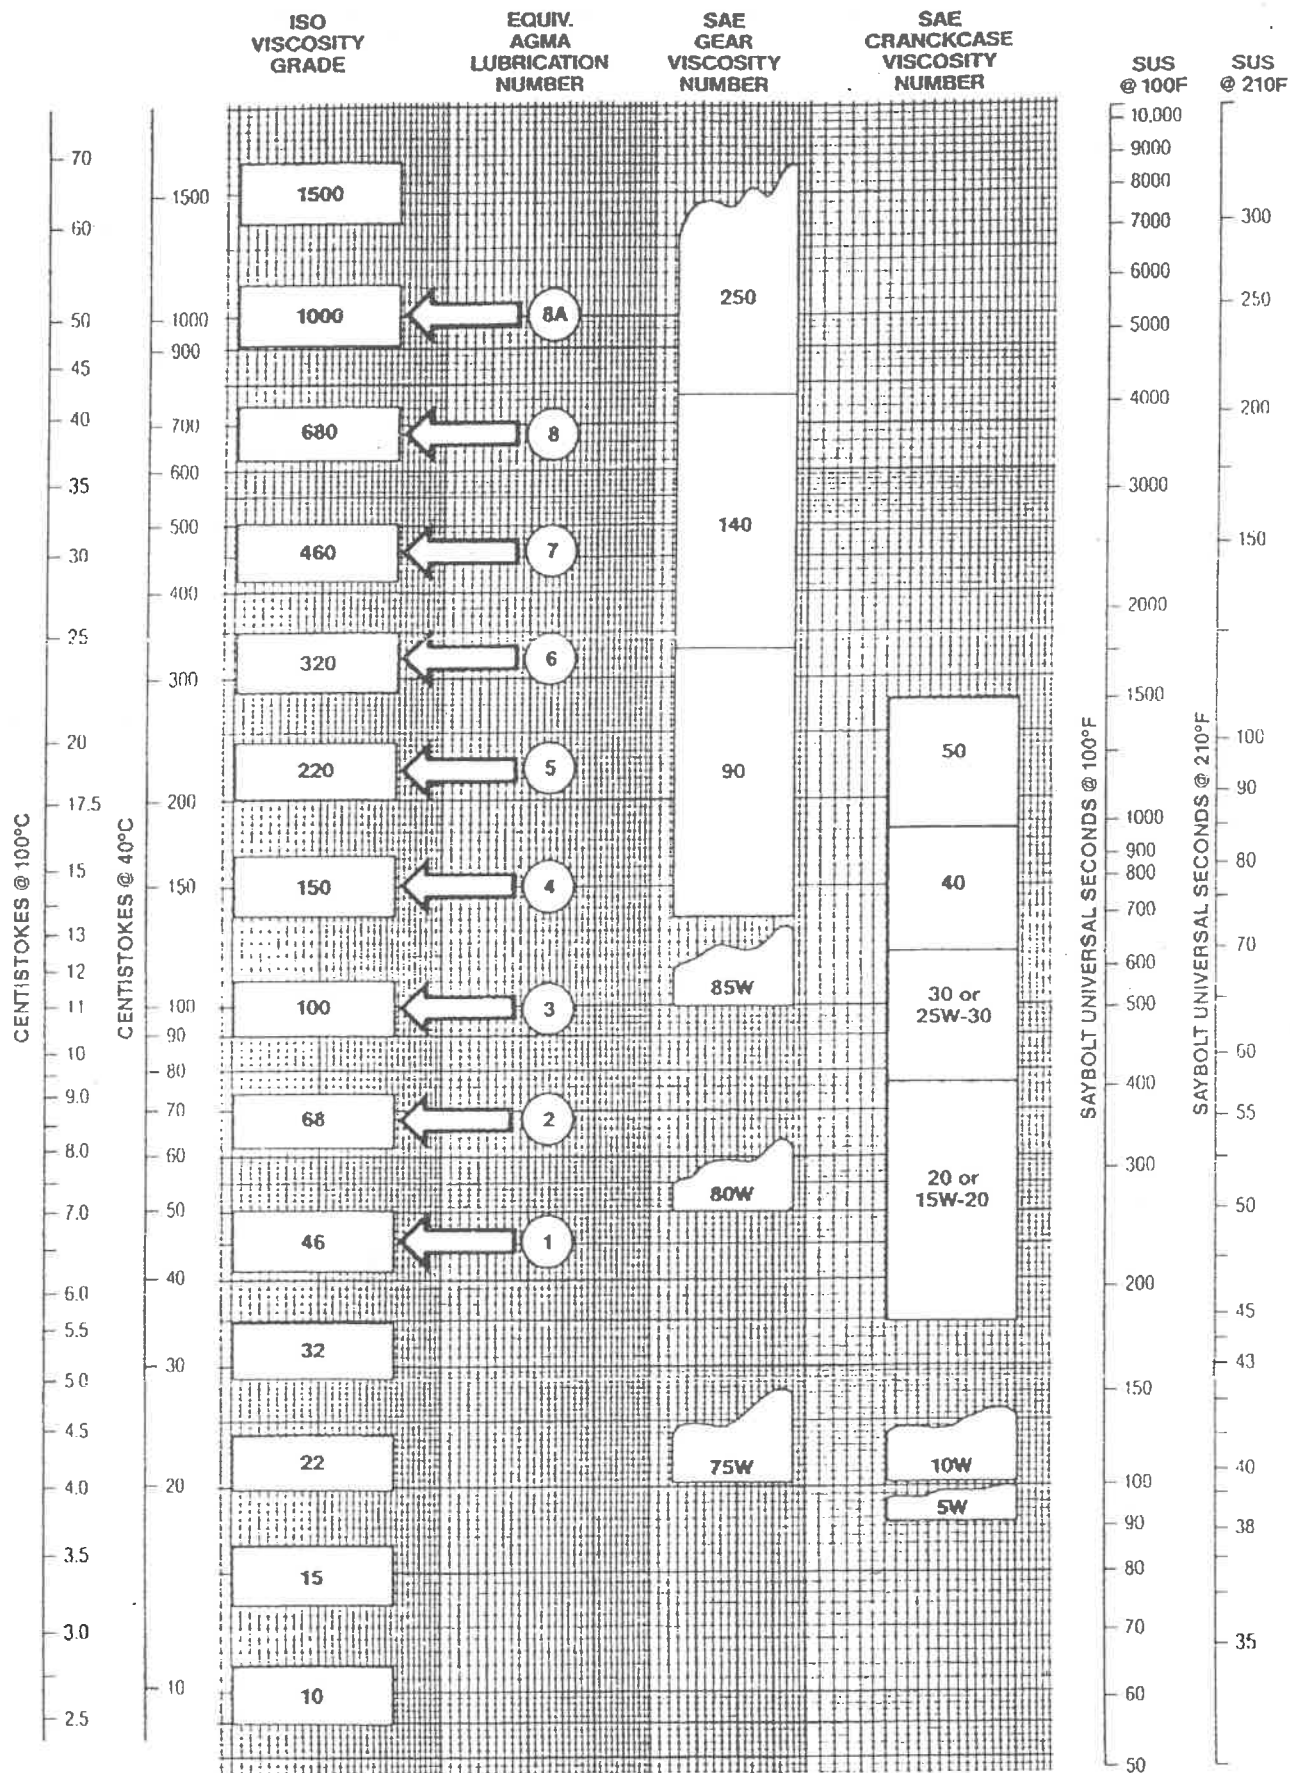
COMPARATIVE VISCOSITY CLASSIFICATIONS

VISCOSITIES AT VARIOUS TEMPERATURES ASSUME 95 VI OILS

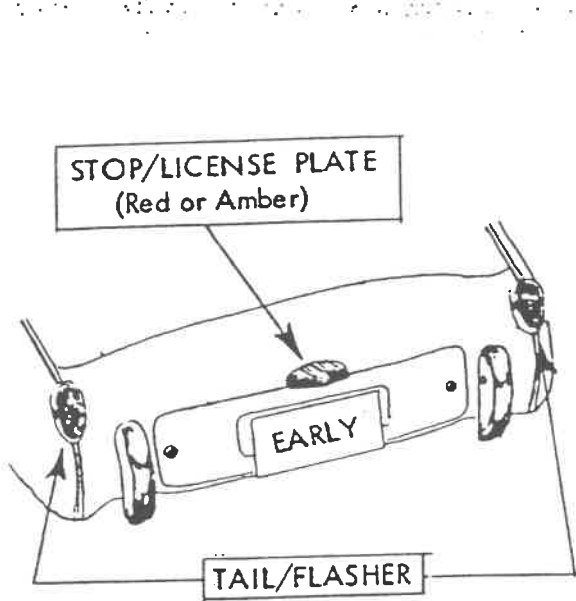
TS1-1300

The lower illustration shows the slightly smaller and more squared-off tail light lens used on the first 1300 TR-2s with many of them having the small round reflector stuck on below it. Beginning at TS 1301, the lens was the same for the rest of the series.

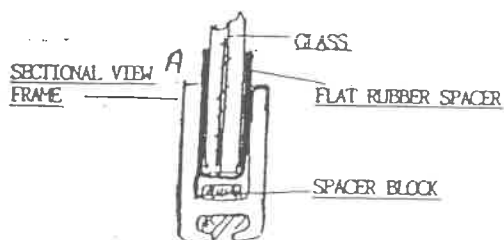
SECTIONAL VIEW B.

Remove glass from frame, take flat rubber pieces (10) and use to centralise glass frame as in sectional view. A

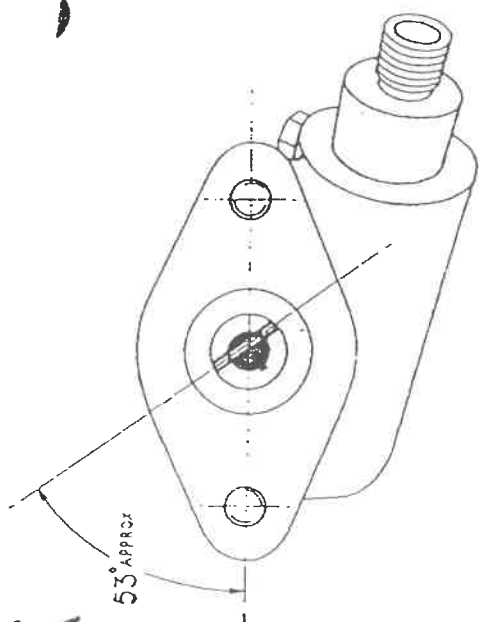
SLOT position in the distributor boss as No. 1 piston comes up to T.D.C.

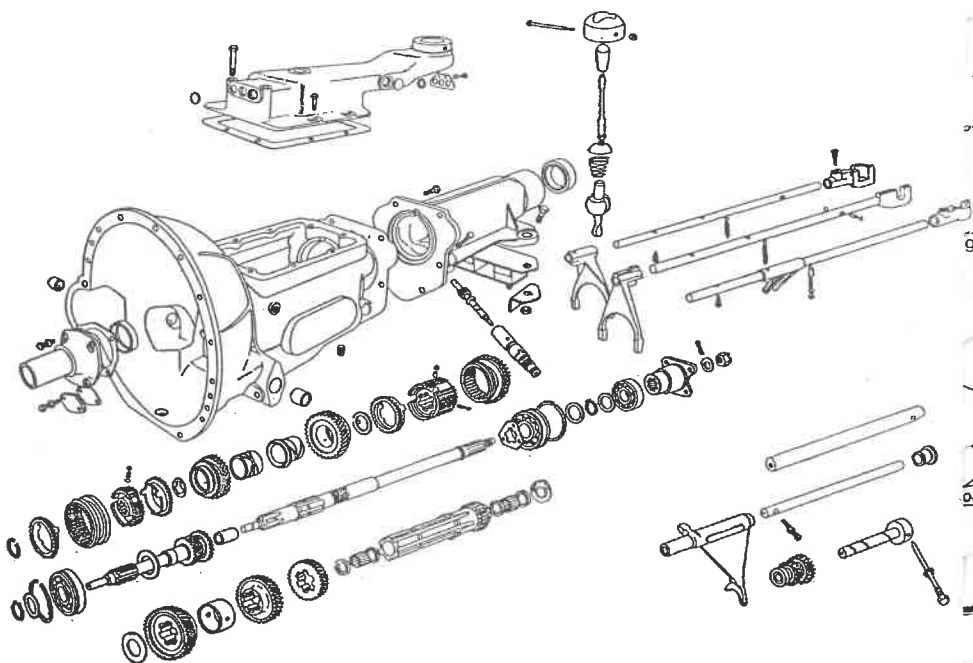
Gearbox, showing details of casing, gear trains selectors and remote control linkage.

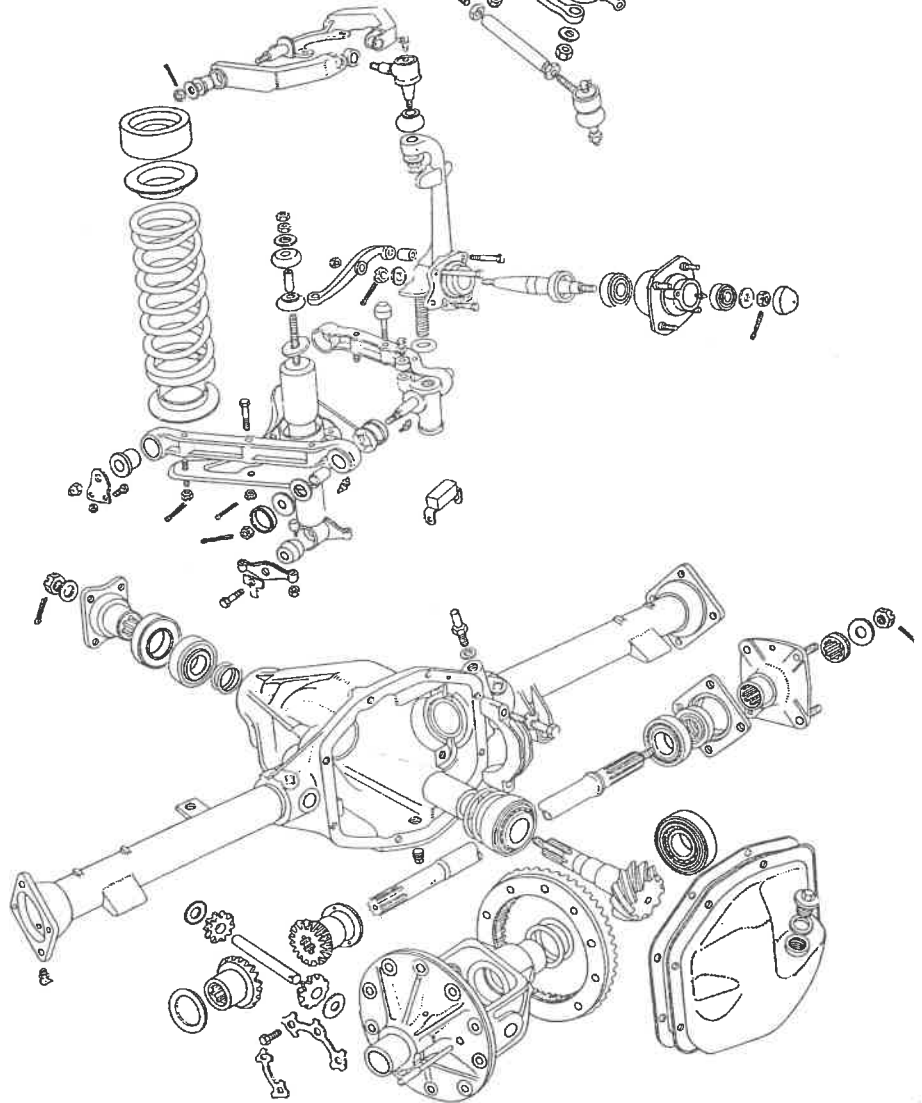
Above: Steering column, box and linkage. Centre: Components of the front suspension. Below: Rear axle showing components of hub, final drive and differential.

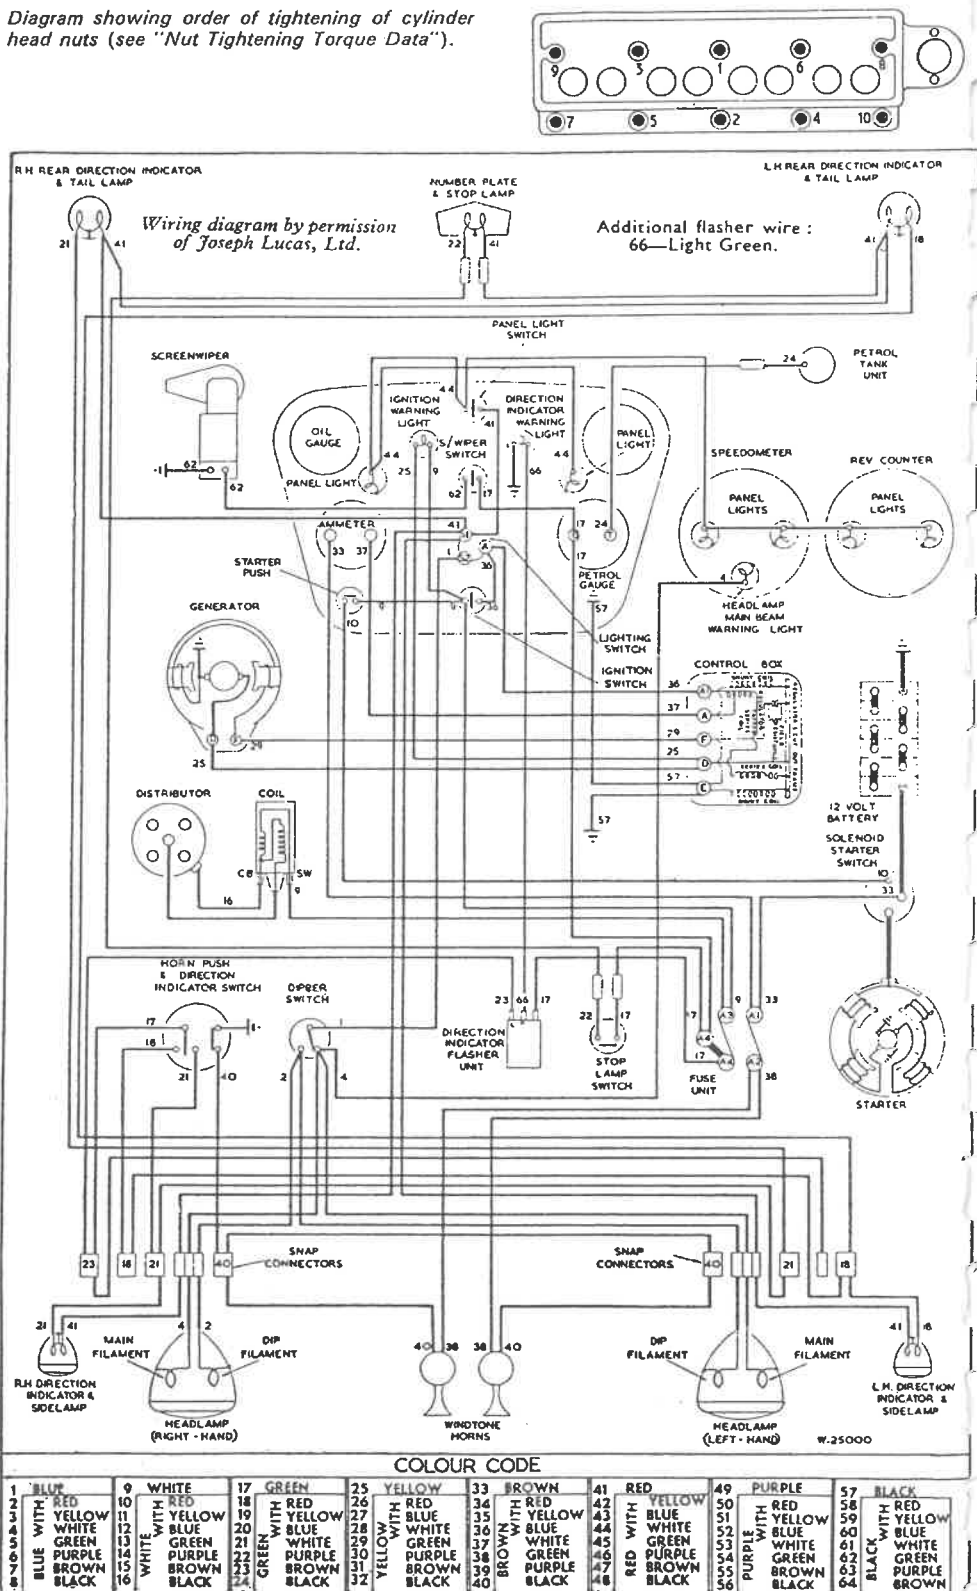
Diagram showing order of tightening of cylinder head nuts (see "Nut Tightening Torque Data").
